Miller Creek Aerial Mapping

Aerial LiDAR Survey Swinomish Channel Jetty, LaConner, WA

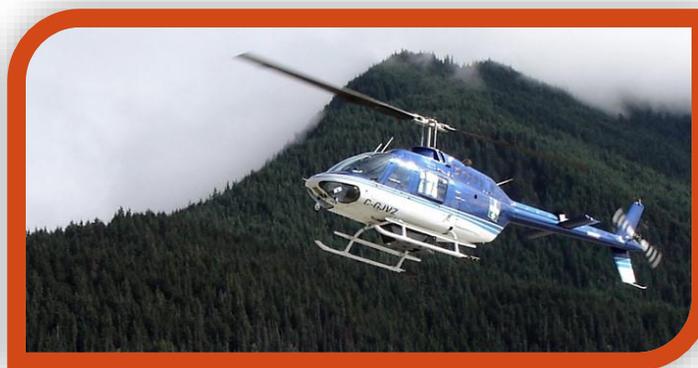
The LiDAR acquisition was performed by TRSI on August 10, 2014 in a Bell 206 B3 Jet Ranger Helicopter. TRSI using a Riegl Model VQ-480 LiDAR system. This is a compact efficient LiDAR sensor that uses rotating prism technology that transmits a uniform density of pulses over the entire scan angle. The system has a variable Pulse Repetition Rate up to 300 KHz. As specified, the acquisition was performed with the tide conditions of <0ft MLLW.

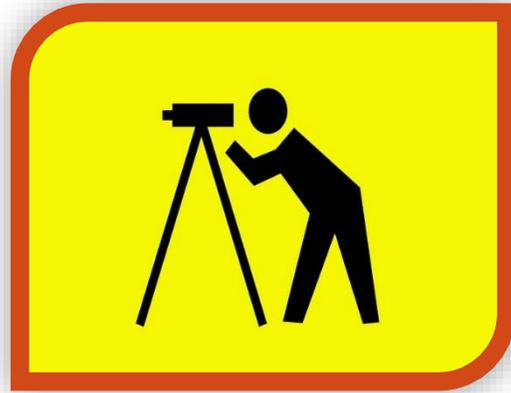
APS collected 22 survey check points in areas of relatively easy access (principally at the northern end of the project). The initial values were observed and collected using RTK GPS methods (± 0.16 feet horizontal & vertical accuracy), with frequent checks shots into the 3.5 inch USACE Aluminum Monument "MARTHA 2008" [WSPC North Zone in US Survey Feet =N(y) 506387.14 E(x) 1230203.53 and NAVD88 elevation = 10.67 feet]. By comparing the record elevation of "TIDAL 3 (PID TR0236)" a USC&GS First Order Class II monument [23.55 feet NAVD88] with the published tidal data from 9448558, La Conner, Swinomish Slough, WA [7.638 meters MLLW = 25.06 feet MLLW] the difference between NAVD88 and MLLW in the Swinomish Slough is 1.51 feet.

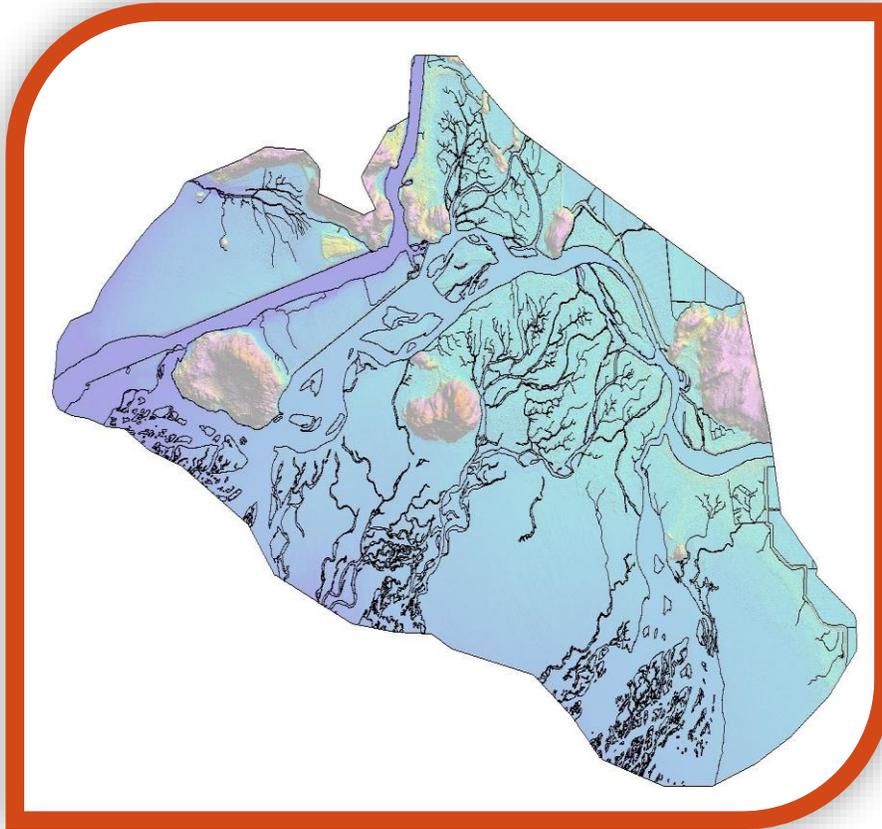
Breaklines for water features are defined in 2D for wider waters and natively in 3D for narrow creek/stream features.

In the case of hydrology with no apparent gradient (lakes, ponds and oceans) each vertex is projected to the lowest LiDAR hit within or near the hydrological feature.

In the case of hydrology with a downhill gradient (double-edged rivers and streams) hydrological edges are derived in a planimetric view. An alignment is then derived from the approximate centerline of edge features, which is downhill-enforced and projected to a lowest local minimum along the alignment. The 2D planimetric edge elements are projected to 3D by a linear interpolation from the orthogonal intersection of an edge vertex with the alignment. Vertices can optionally be introduced at this 3D intersection to enforce orthogonal elevations spanning the hydrological feature.
